REPORT NO. 95-01

PALLETIZED LOADING
SYSTEM (PLS) FLATRACK
SIDEBOARD KIT
EVALUATION

A. BACKGROUND. The U.S. Army Defense Ammunition Center and School (USADACS), Validation Engineering Division (SMCAC-DEV) was tasked by U.S. Army Tank-automotive and Armaments Command (TACOM) to design and test concepts for a sideboard kit for the M1077 Palletized Loading System (PLS) A-frame pallet. The basic design was forwarded by TACOM and the prototype developed by USADACS, Supply Engineering Division (SMCAC-DES). The PLS testing requirements outlined a requirement for the sideboard kit to retain a loose pallet as it slid from one end of an M1077 flatrack while it was being loaded onto the PLS truck.

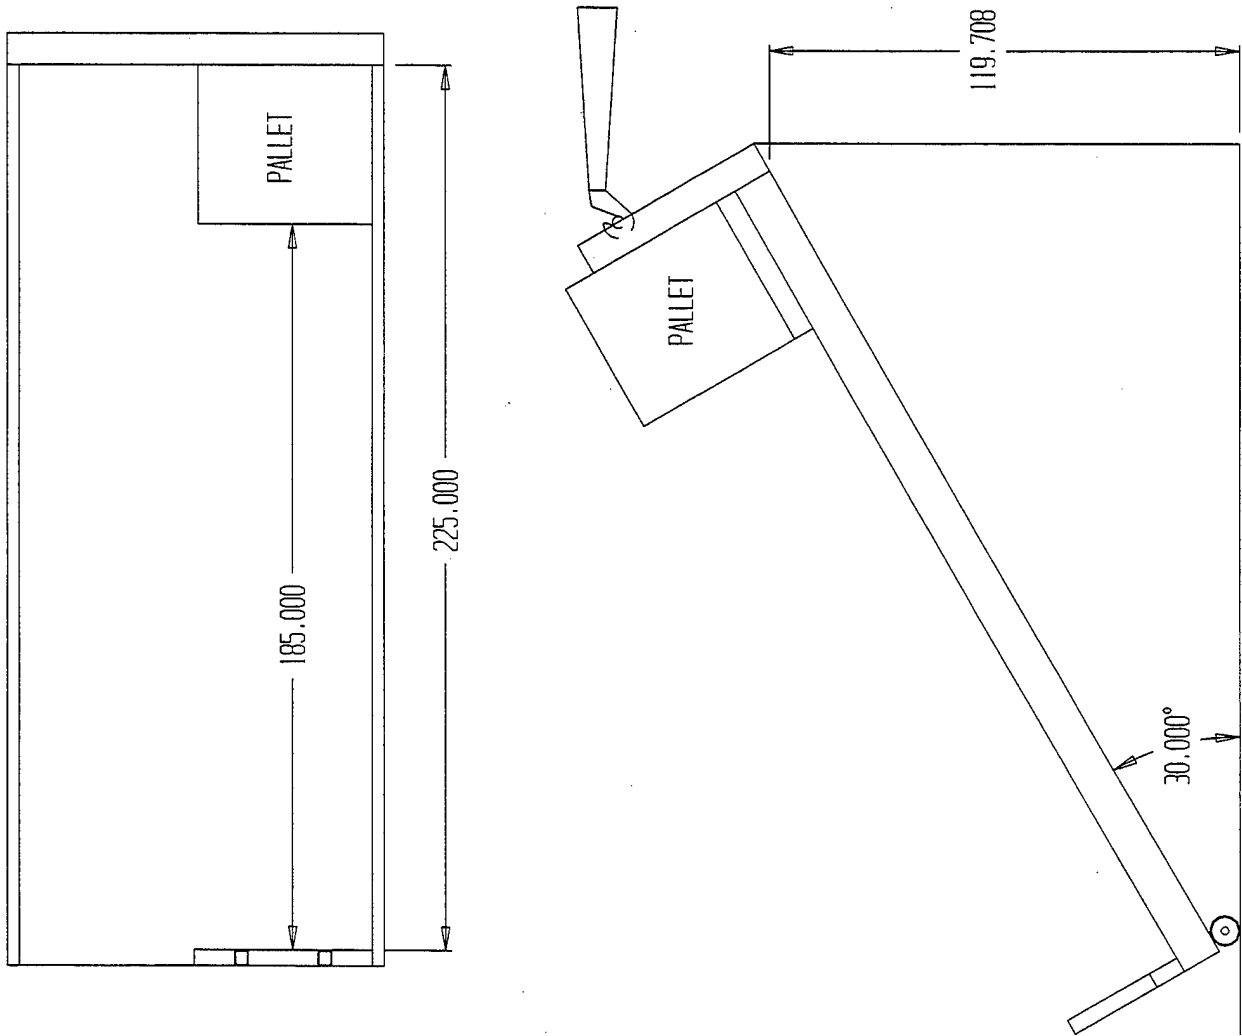
Figure 1

The M1077 flatrack was raised to 119 inches before the pallet overcame static friction (see Figure 1, page 4-2). The pallet slide path was 185 inches to the rear sideboard. The critical angle was 31 degrees.
